TECHNICAL NOTE 3847

FATIGUE-CRACK-PROPAGATION AND RESIDUAL-STATIC-STRENGTH  
RESULTS ON FULL-SCALE TRANSPORT-AIRPLANE WINGS

By Richard E. Whaley, M. J. McGuigan, Jr.,  
and D. F. Bryan

Langley Aeronautical Laboratory  
Langley Field, Va.

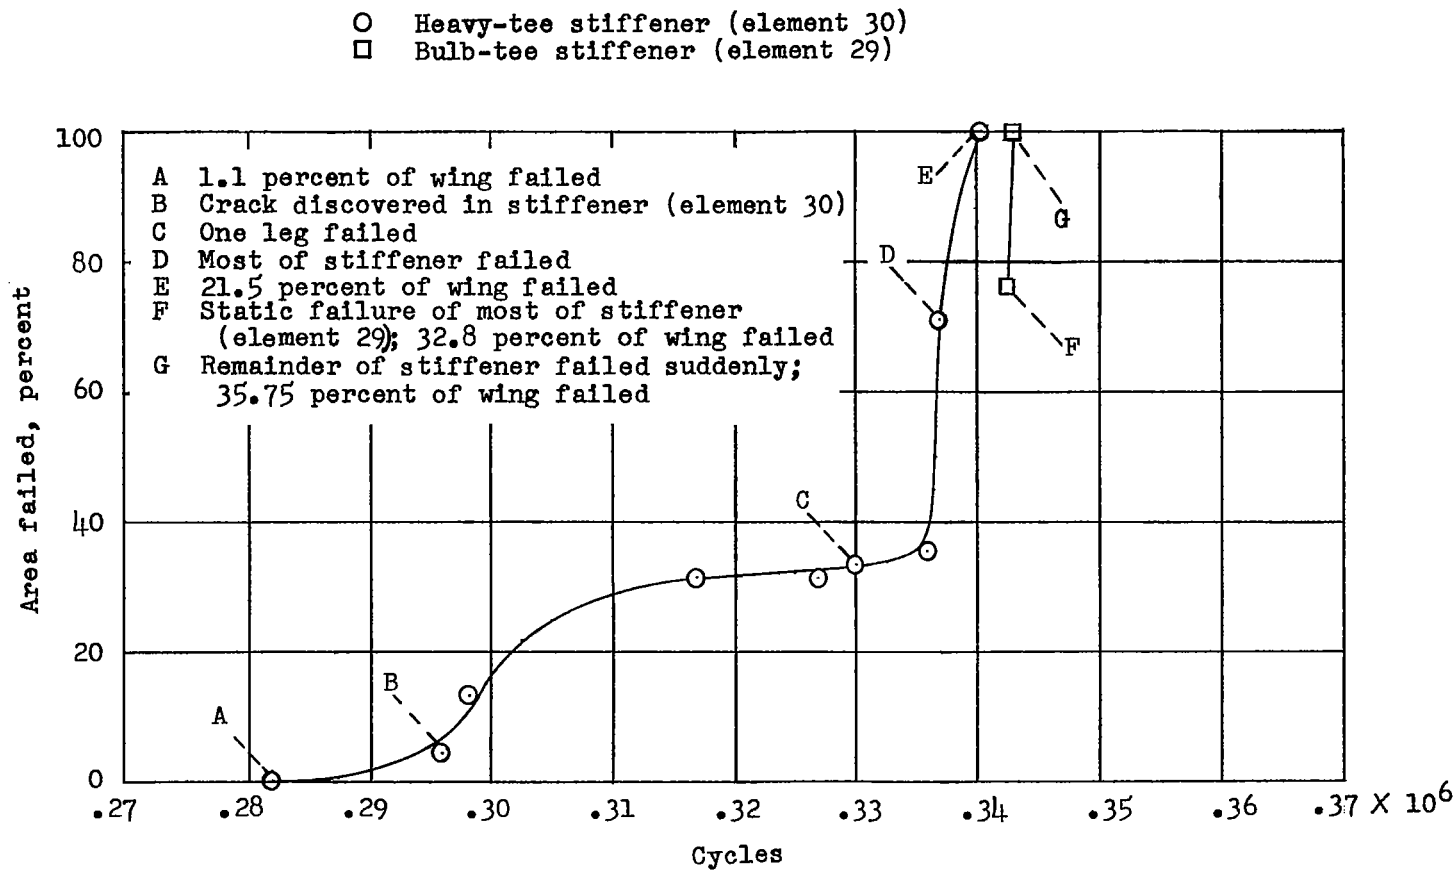
(b) Crack 15;  $\Delta n = 0.625$ .

Another propagation curve similar to the propagation curves of the entire wing structure was obtained from another element. This curve is shown in figure 9(b). This element is the heavy tee stiffener (element 30). Although the load level  $\Delta n$  of the test was 0.625, the rate of progress of the crack was slow. One reason for this was that element 30 had a larger area than any other element in the wing and started to fail when the wing had a little more than 1 percent of the entire area failed. The most noticeable difference between this curve and the wing propagation curves was that the critical point occurred at about 35 percent of the area of the element. That point corresponded with the critical point for the whole wing at which time 5.8 percent of the wing tension area was failed. The shape of these stiffener propagation curves depends on the alternating load level and the increase in stress in the stiffener during the test. The failure of the surrounding material causes more load to be added progressively to the stiffener and thus increases the stress. Since the cracks progress through the elements in slightly different orders in each wing, the stiffener propagation curves are subject to some variation.

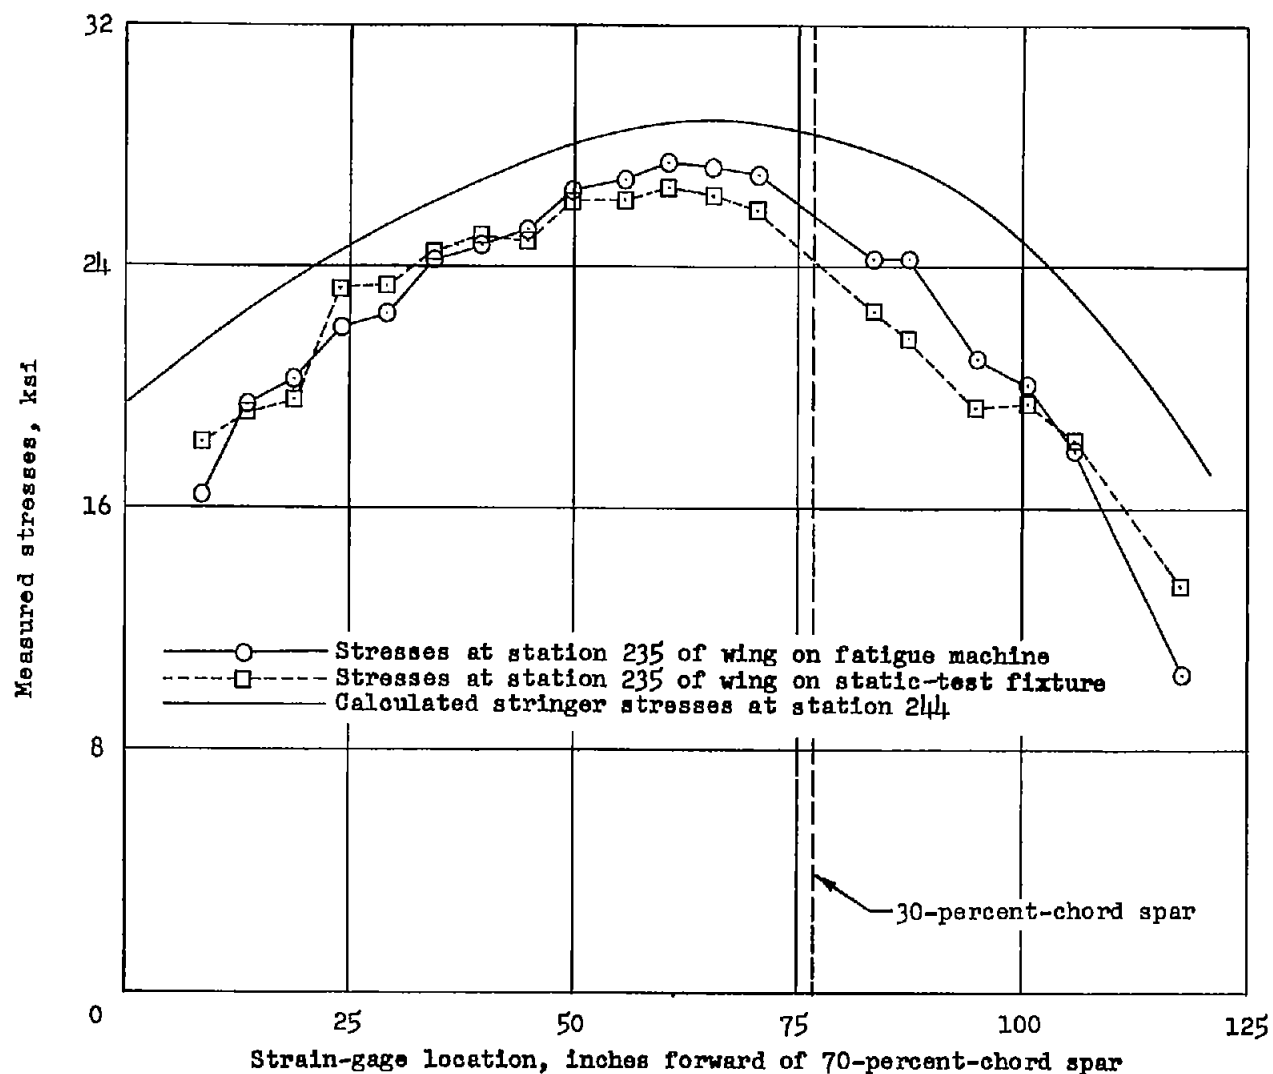
Figure 10.- Chordwise distribution of skin and stringer stresses for 4.0g loading.

The stress distribution in the wing when loaded on the static-test fixture was very nearly the same as that when the outer panels were loaded while attached in the normal manner on the wing center section in the fatigue testing machine. The chordwise stress distribution is shown in figure 10 for a loading of 4.0g which is applied in both loading devices. The station chosen for this survey (station 235) was the closest station to the area of interest which was free of cutouts, doublers, and other discontinuities. It may be seen from this figure that the chordwise location of the points of maximum stress agrees well with each other and that the difference between the curves obtained from the two loading systems is small. Also included in this figure for comparison is the chordwise distribution of design bending stresses obtained from the structural analysis of the airplane.

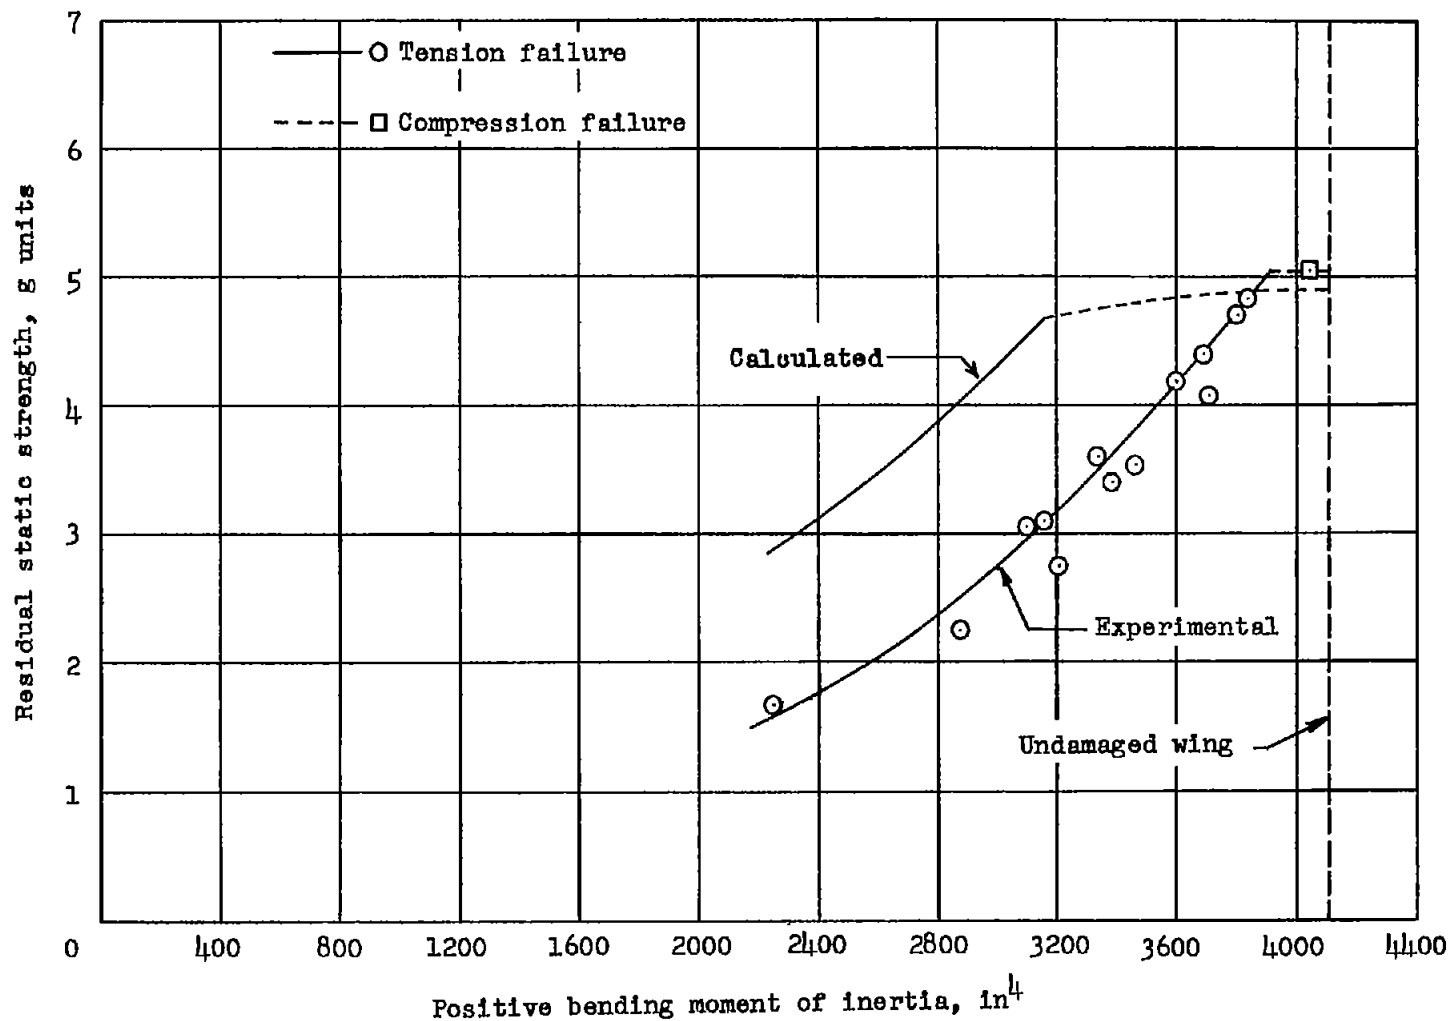
Figure 12.- Residual static strength of C-46 wing in positive bending.

The residual static strength of the C-46 wing based on design-load considerations was very good, as indicated by figure 12, principally because of the large margins of safety in the lower surface of the wing for the positive-loading case. These large margins resulted in relatively small reduction in the bending strength of the whole wing even though the strength of the tension surface itself had been considerably reduced. The large margins of safety for the positive design load were occasioned by the fact that the lower surface of the wing was critical in the negative-loading case in which very small margins were present. In other words, in order to have adequate strength for the negative design load, the lower surface had excess strength in the positive-design-load case.

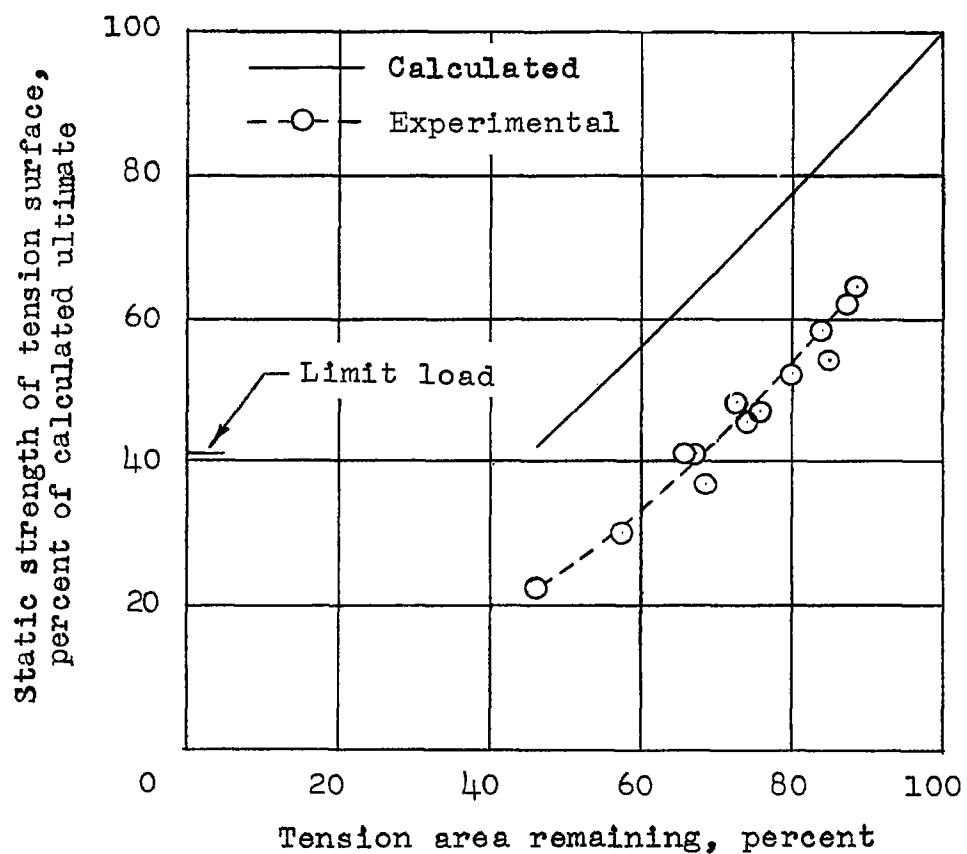
Figure 13.- Residual static strength of tension surface of C-46 wing.

This reduction in strength is shown clearly in figure 13 in which the static strength of the tension surface of the wing is plotted against the percent of cross-sectional tension area remaining in the wing. The solid line in figure 13 shows the relationship between the calculated strength of the tension surface and the tension area remaining after fatigue failure. The calculated strength is based on the reduced section properties of the wing after the fatigue test. Structural analysis of the wing indicated the strength of the tension surface of an undamaged wing to be about 40 percent greater than that of the compression surface for positive bending loads. The calculations indicated that if the compression surface did not buckle the strength of the tension surface would be 7.49g. This value was therefore used as the calculated static strength of an undamaged tension surface, and the actual static strengths obtained from the tests are plotted as a percentage of this figure. No static-strength reduction factor due to holes or cutouts was used in this calculation.

It can be seen in figure 13 that the actual strength is less than the calculated strength by about the same amount throughout the range of the test values. This reduction amounts to about 23 percent of the static strength of an undamaged wing. This reduction in strength can also be expressed as a static-strength reduction factor which is defined here as the ratio between the calculated strength and the actual strength at the same percentage of material remaining. This factor is calculated for each wing and is listed in table III. In figure 14 this static-strength reduction factor is plotted against the percent of tension area remaining in the wing. This figure indicates that as the amount of tension area remaining in the wing decreases the static-strength reduction factor increases. This increase is due to the static strength decreasing while the difference between the calculated strength and the actual strength remains constant. This factor can be used directly along with the calculated strength to find the actual strength.

The residual-static-strength data, figure 13, indicate that the C-46 wing could withstand, without failure, a positive gust which produced a load factor equivalent to the design limit load with as much as 30 percent of the lower cross-sectional area failed in fatigue. Therefore, a considerable length of time should exist in which the crack would be large enough to be easily discovered and during this time the wing could withstand without catastrophic failure any load that the airplane would be likely to encounter.

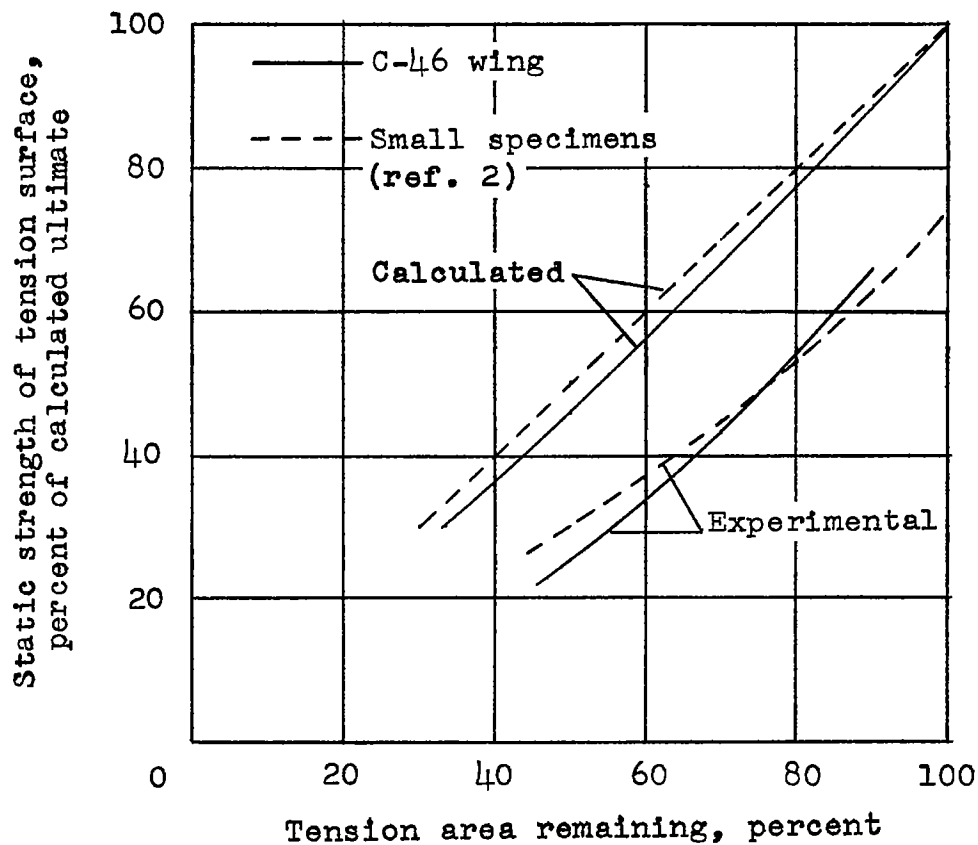
Figure 15.- Comparison of residual static strengths of C-46 wing and small specimens.

In figure 15 the residual static strength of the wing tension surface is compared with the results of tension tests conducted on  $2\frac{1}{4}$ -inch-wide 2024-T3 aluminum specimens (ref. 2). It can be seen that there is remarkably good agreement between the two. Extrapolation of the results of the full-scale tests to near the region of the undamaged wing indicates that a considerable reduction in static strength of the tension surface would result from a very small fatigue crack.
